**FATIGUE RESPONSE OF THIN STIFFENED
ALUMINUM CRACKED PANELS REPAIRED
WITH BONDED COMPOSITE PATCHES**

THESIS

Jason B. Avram, Captain, USAF

AFIT/GMS/ENY/01M-01

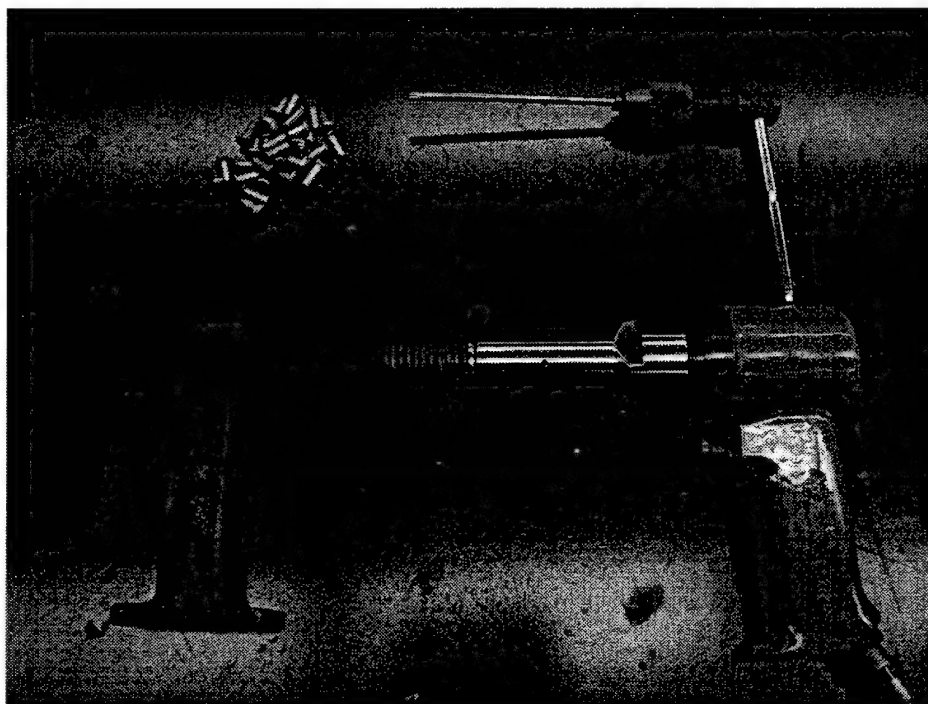
The stiffeners were attached to the panels using a pneumatic riveting process. All tools needed (rivets, reamer, bucking bar, and pneumatic rivet gun) are shown in Figure 22. The rivet holes in the stiffeners and panels were first "reamed" to 4.85 mm (0.191") to ensure the proper size for the rivets and to reduce the chances of fatigue crack initiation in the holes. This process is shown in Figure 23. Rivets were then inserted into the holes and installed one at a time. This consisted of placing the rivet gun against the head of the rivet and the bucking bar against the butt. As the gun hit the rivet, the bucking bar deformed the butt and the rivet filled the hole. Because the panel tends to expand slightly as it is riveted, it is best to work from the center of the panel out toward the ends to reduce any deformity in the panel. This process is shown in Figure 24, Figure 25, and Figure 26.

Figure 22 Riveting Tools

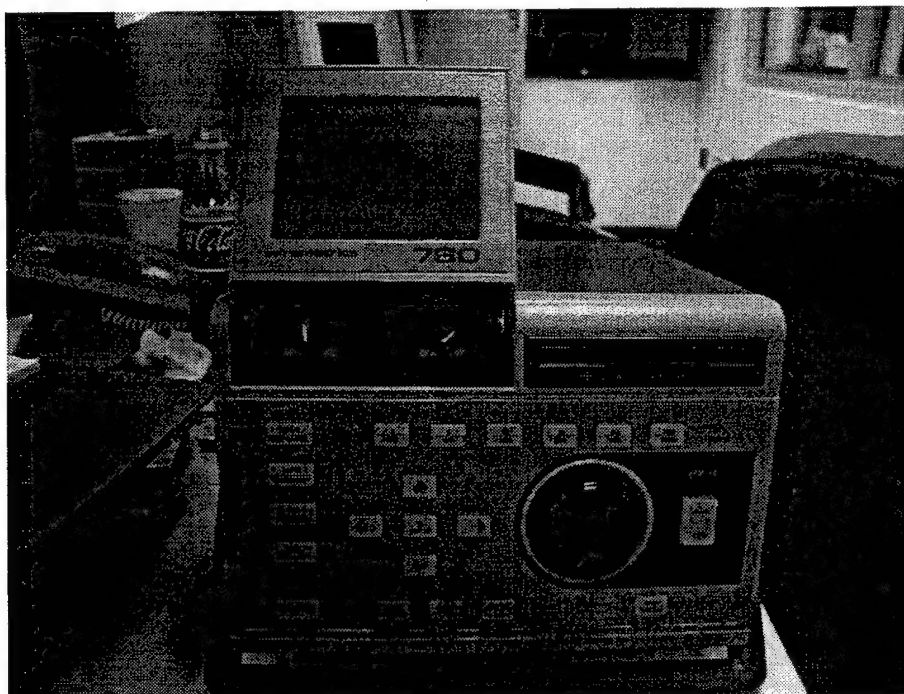
Figure 30 Inframetrics 760 IR Data Acquisition Device
